La Mejor Manera de Mejorar y Proteger el Suelo

ProGanics® BSM™ y EcoFlex® HP-FGM®

CASE STUDY

Mine Closure

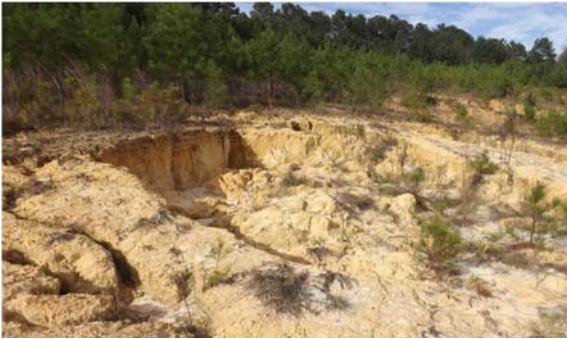
Large gullies formed due to erosion

For 13 years, an abandoned mine in the Southeastern U.S. sat partially barren. A large mining company worked to revegetate 5 acres (2 hectares) of the sprawling site several times over the years with traditional standard seeding. Every time the site saw significant rain, their seed and soil washed away. Profile® met with the project consultant for a Lunch & Learn and later stepped in to assist with the problematic site.

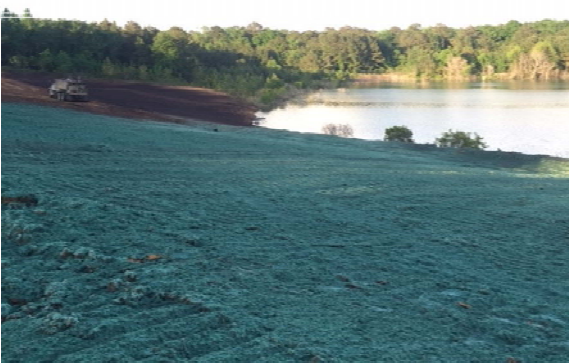
ProGanics and Flexterra applied to soil in April

- Soil tests to assess the site's agronomic value
- Slope redesign to include a terrace and cat tracking to reduce overland flow
- ProGanics™ BSM™ applied at 4,500 lb/ac (5,040 kg/ha)
- Flexterra® HP-FGM™ applied at 3,500 lb/ac (3,920 kg/ha)
- NeutraLime™ applied at 160 lb/ac (179 kg/ha) to raise soil pH
- JumpStart™ fast acting biostimulant applied at 5 gal/ac (47 L/ha)
- BioPrime™ slow release biostimulant applied at 160 lb/ac (179 kg/ha)

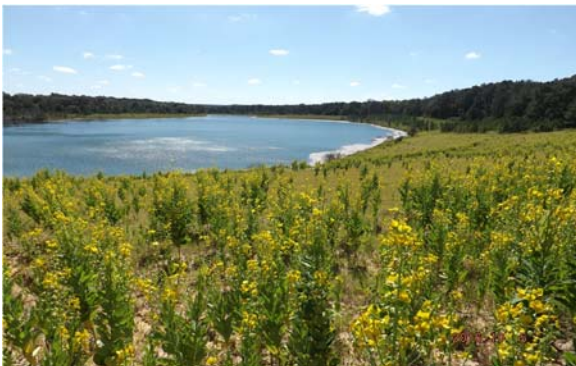
Sustainable vegetation one year later

During follow up inspections a year later, Profile technical experts confirmed that soil health had dramatically improved:

- A five-fold increase in organic matter from 0.4 percent to 2.0 percent
- 271 percent increase in soil respiration
- 345 percent increase in bacterial counts
- 142 percent increase in fungal counts

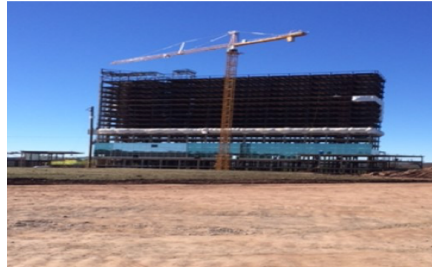
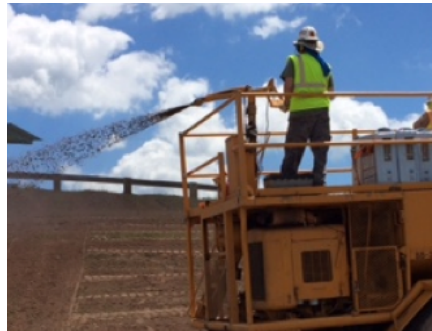
*Top: Construction on the resort
Bottom: ProGanics application on a slope*

Profile's partners also took multiple soil tests across the site and found several areas with deficient soils. To restore the soil, the team applied ProGanics® Biotic Soil Media™ (BSM™), an Engineered Soil Media™ (ESM™) that provides the organic matter and soil-building components to modify the soil chemistry and initiate growth and sustainable vegetative establishment. With the long winter on the horizon, a team of hydroseeding companies quickly worked to apply the ProGanics and Flexterra to the site. Within a few weeks, vegetation began to establish. The engineering firm noted the Flexterra application held the seed and soil in place, eliminating worries about sediment pollution. During follow-up inspections in 2018, the site had established sustainable vegetation. The success of this project earned Profile the opportunity to consult on additional projects on the site over the next few years.

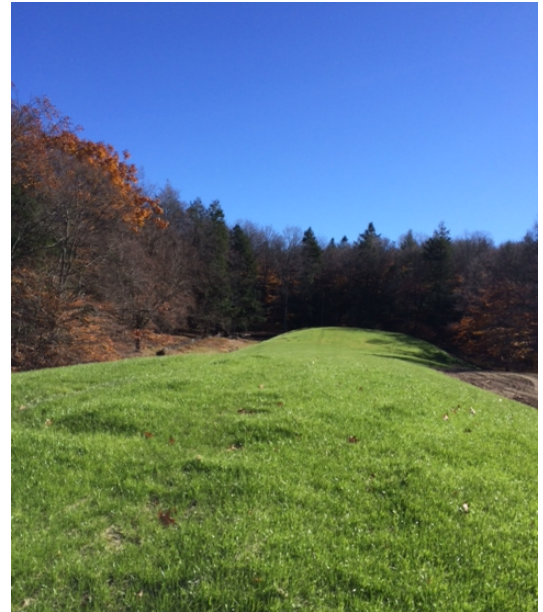
Vegetation began to establish within weeks of application, and the site was fully vegetated in follow up inspections one year later

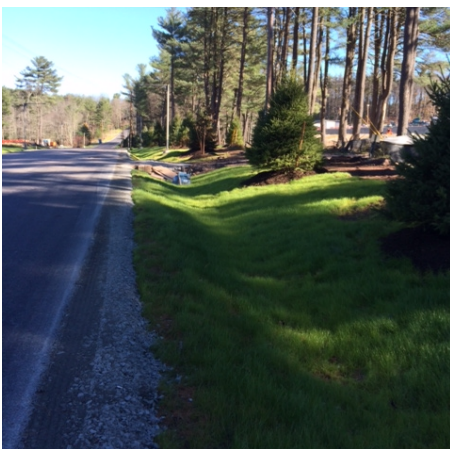
Follow-up inspections saw significant growth, including along the roadways
